REPORT NAEC-92-129

WEAR PARTICLE ANALYSIS OF GREASE SAMPLES

Handling and Servicing/Armament Division
Ground Support Equipment Department
Naval Air Engineering Center
Lakehurst, New Jersey 08733

Technical Report
Contract NAVY N68335-76-C-2281

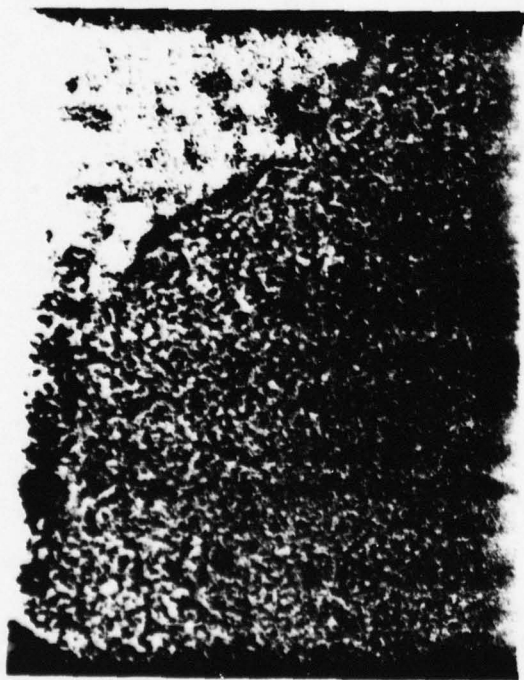
Photo No. F1428-4 Magnification: 100X

Bichromatic light photo of same material in Photo F1428-3 above. Shows chiefly amorphous nature of undissolved grease.

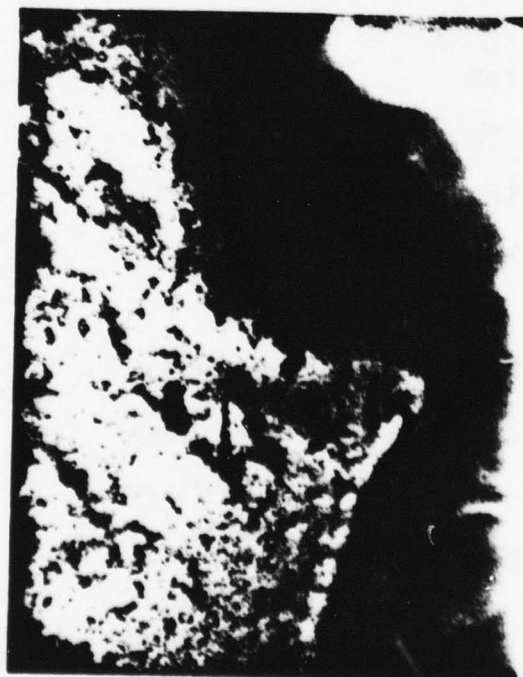
Photo No. F1428-6 Magnification: 100X

Another view down the Ferrogram of material thought to be lithium soap apparently swollen by Solvent #1.

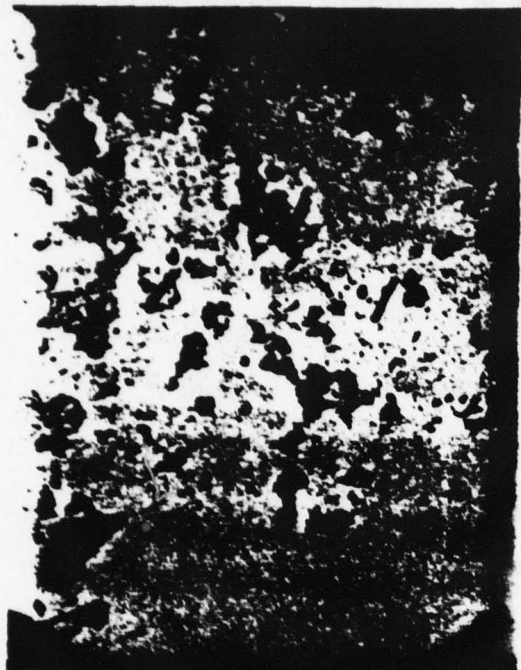
Photo No. F1437-7 Magnification: 100X

Sample dissolved in grease Solvent #3,
(high aliphatic content). Good solvation.
No grease or soap evident. Some thin
non-metallic particulate matter present.

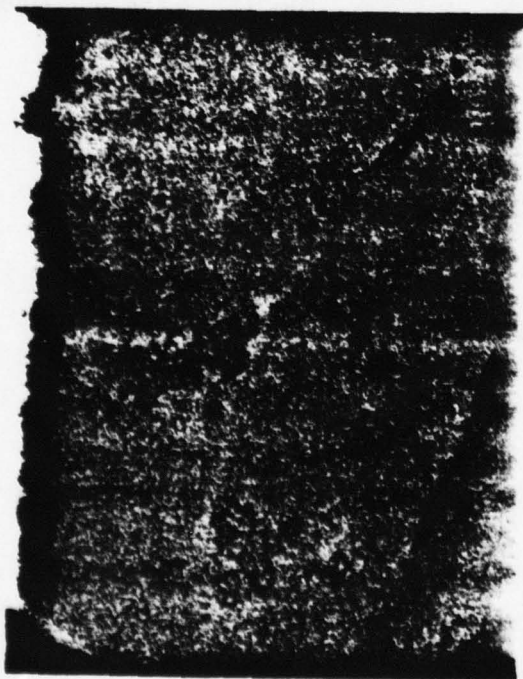
Photo No. F1437-8 Magnification: 100X

All grease and soap solubilized.
Blue/black particles are MoS_2 ,
non-metallic spheres are
unknown material.

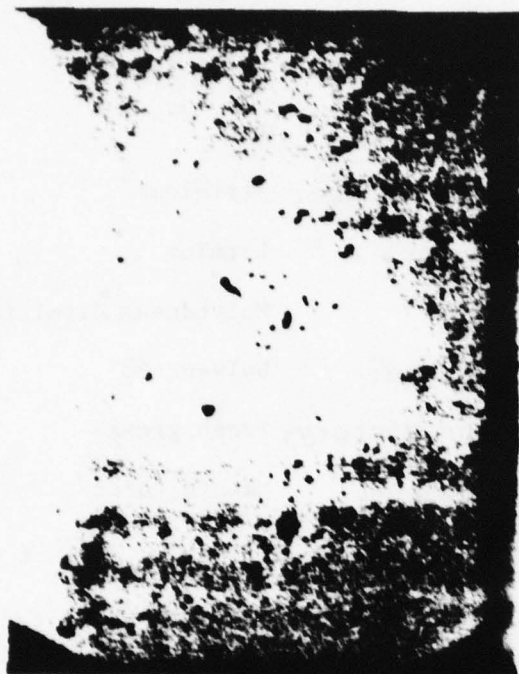
Photo No. F1439-11 Magnification: 100X

Grease dissolved well. Small amount
of non-metallic particulate matter
present (silica).

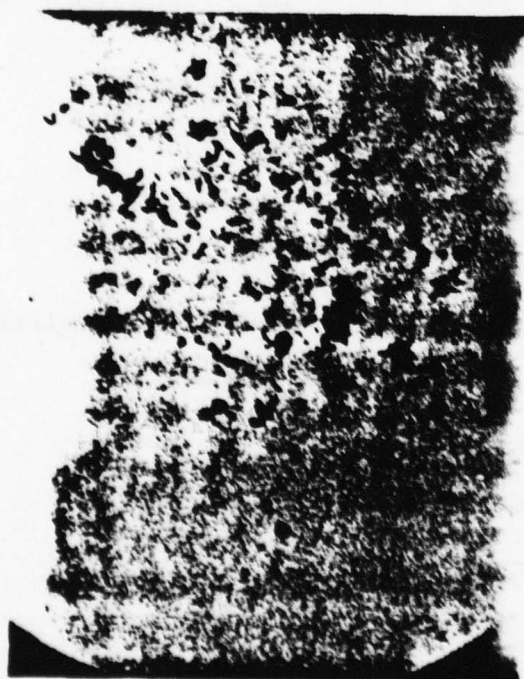
Photo No. F1439-12 Magnification: 400X

Higher magnification photo of
F1439 in bichromatic light shows
the fine silica particles.

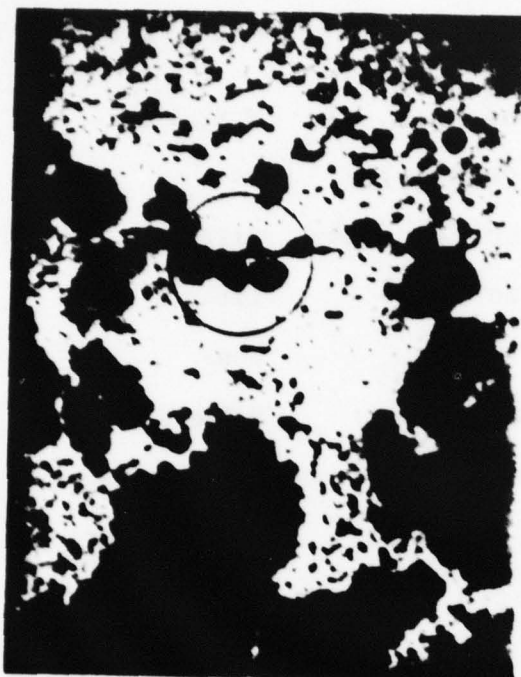
Photo No. F1442-13 Magnification: 100X

Remarks: Some metal particles. Most of deposit is a high concentration of soap materials used in this type of grease. The used silicone greases show an entirely different deposit and these agglomerates disappear under heat and pressure.

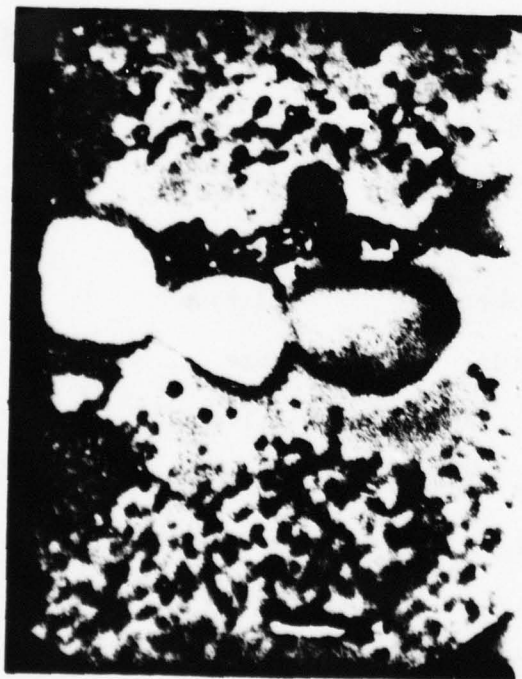
Photo No. F1442-14 Magnification: 400X

An enlarged view of Photo F1442-13 above.

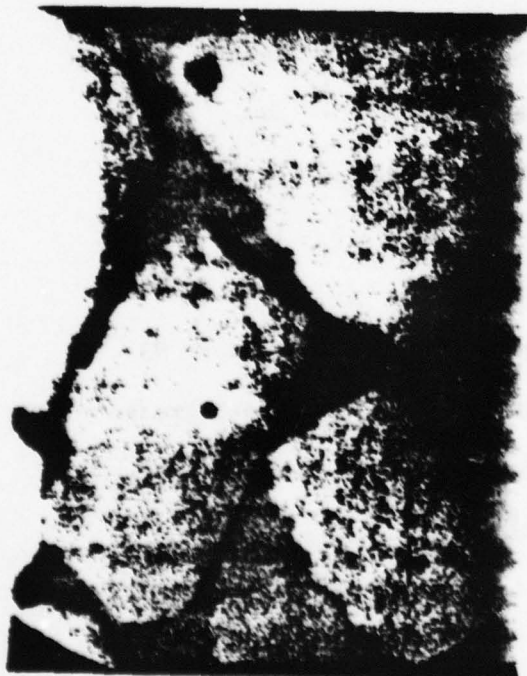
Photo No. F1442-16 Magnification: 400X

Magnified (400X) view of polarized light Photo F1442-15 circled above. No evidence of such structures in used silicone greases. See Photos F1491-36 and F1491-37.

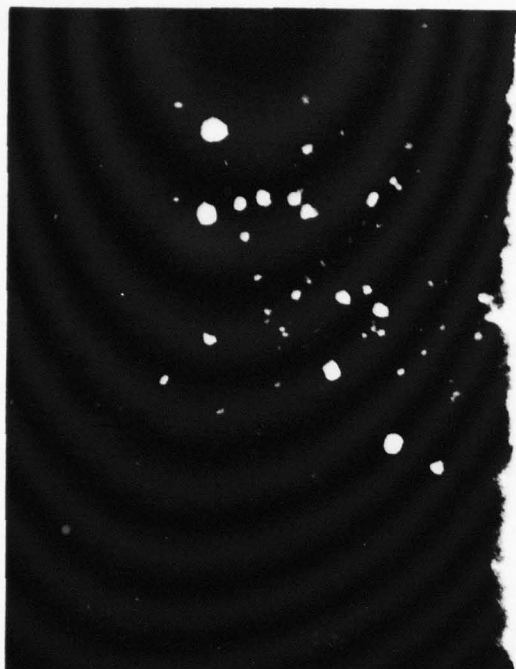
Photo No. F1442-17 Magnification: 100X

This sample diluted 5:1 with Solvent #3.
Large soap particles much reduced in size
compared to original sample shown in
Photos F1442-13 to -16.

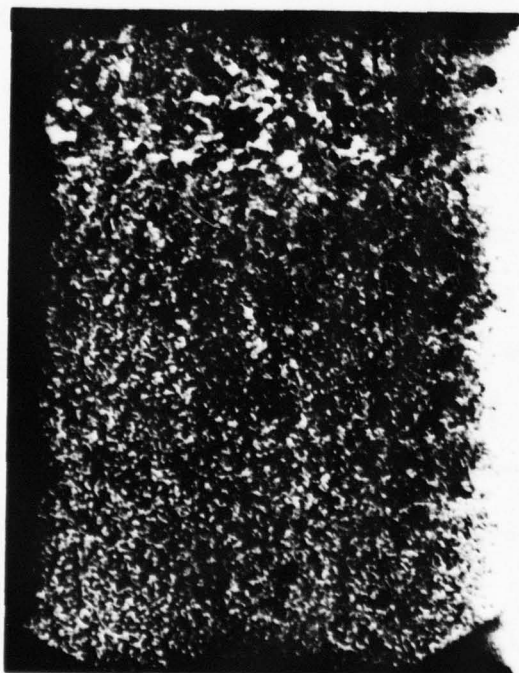
Photo No. F1442-18 Magnification: 400X

Enlarged view (400X) in bichromatic light
of diluted (5:1) fresh silicone grease
sample shows how particles are dispersed.

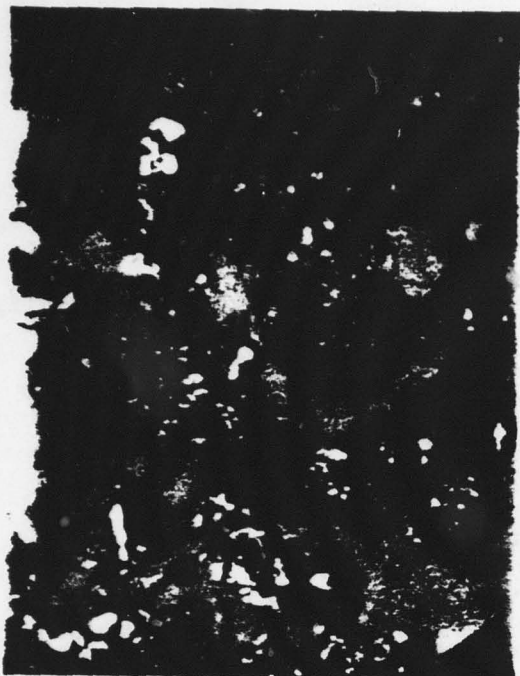
Photo No. F1444-23 Magnification: 400X

Enlarged view (400X) of Photo F1444-22.
Some particles exceed 50 μ m. MoS_2
particles have entirely different
configuration in used greases.

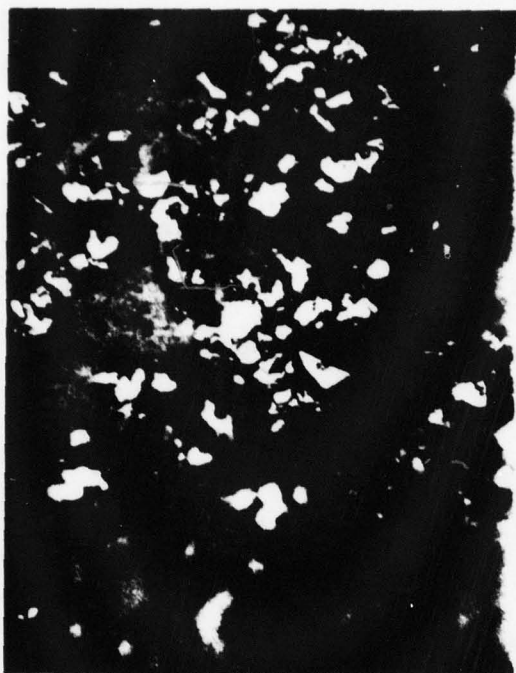
Photo No. F1441-24 Magnification: 400X

MoS₂ particles smaller in size than in grease sample #6. Entry area shows a mixture of MoS₂ and clay.

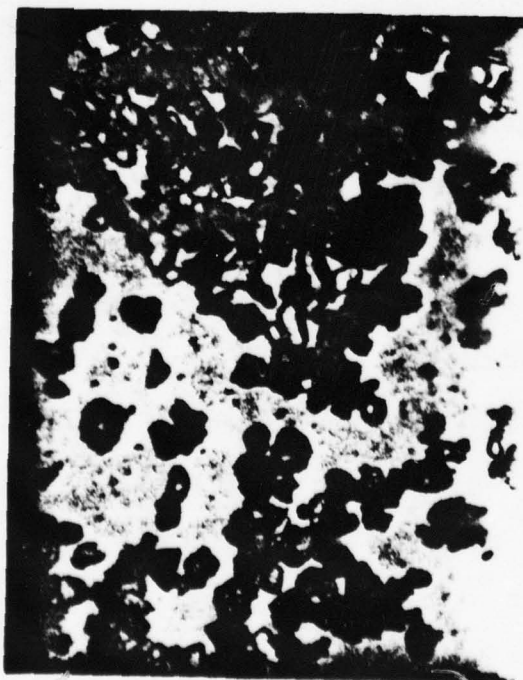
Photo No. F1441-25 Magnification: 400X

Same as Photo F1441-24, but in bichromatic light. Differences between Bentone particles (transparent) and MoS₂ (red).

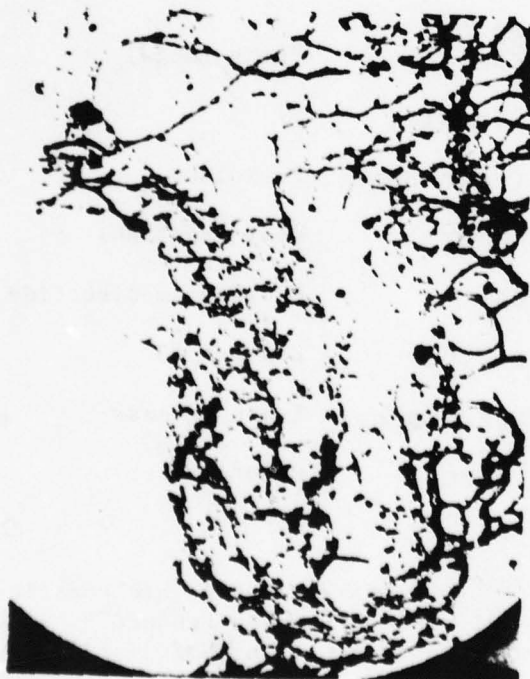
Photo No. F1443-27 Magnification: 400X

Web-like deposit away from entry area @ 51.5 mm.

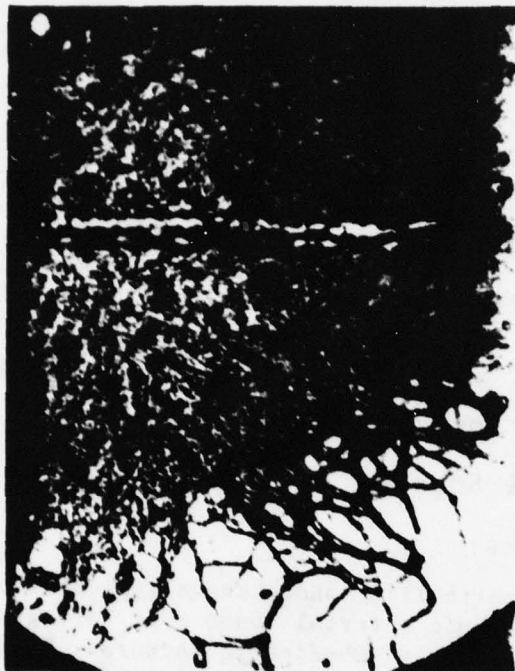
Photo No. F1443-28 Magnification: 400X

Large (200 μ m) metal particle in large
network-like mass of organic material.

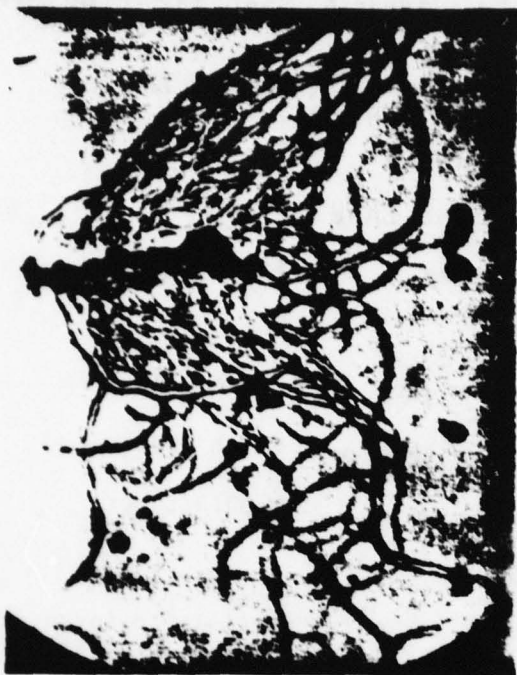
Photo No. F1443-30 Magnification: 400X

The undissolved lithium type grease on the Ferrogram heated to 625°F for 90 seconds. Some smoke evolved from the heat, but otherwise remains stable.

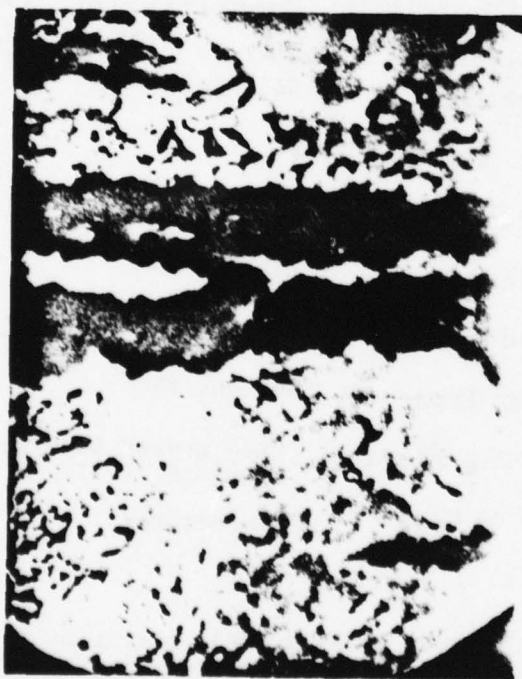
Photo No. F1491-37 Magnification: 400X

Remarks:
Enlarged view (400X) of entry deposit in Bichromatic light. Demonstrates that large amount of soap material in used silicone grease present low interference when observing metal particles microscopically.

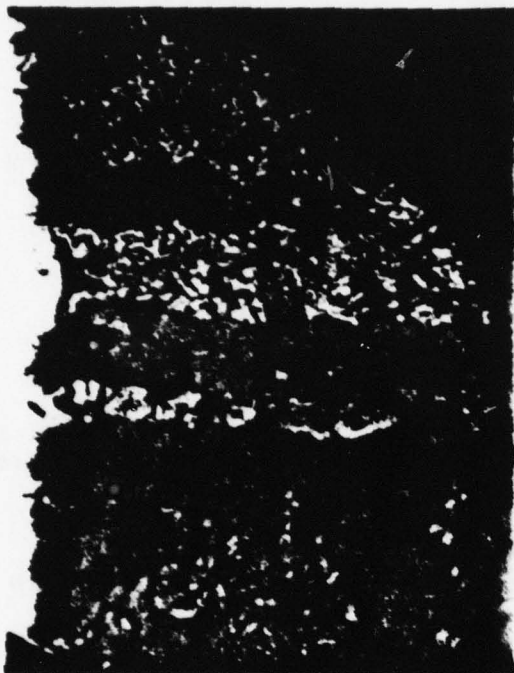
Photo No. F1491-38 Magnification: 400X

Another view in Bichromatic light showing contrast between metallic wear particles and non-metallic debris.

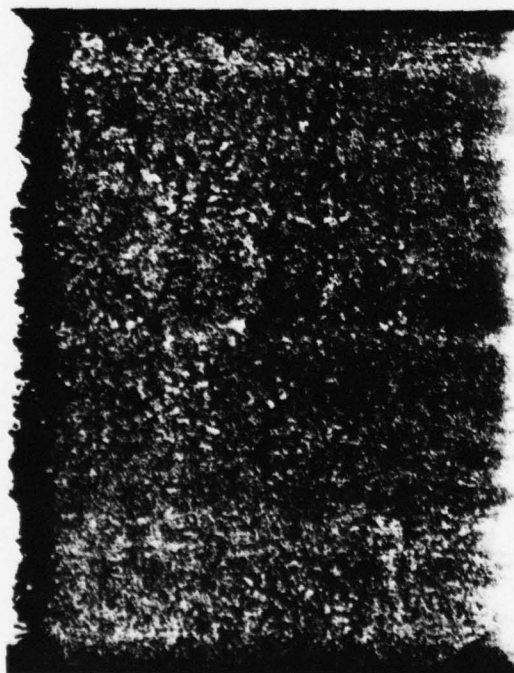
Photo No. F1491-39 Magnification: 400X

Lack of any significant deposit of metal
caused by rapid settling in sample bottle.
Typical of MoS_2 greases.

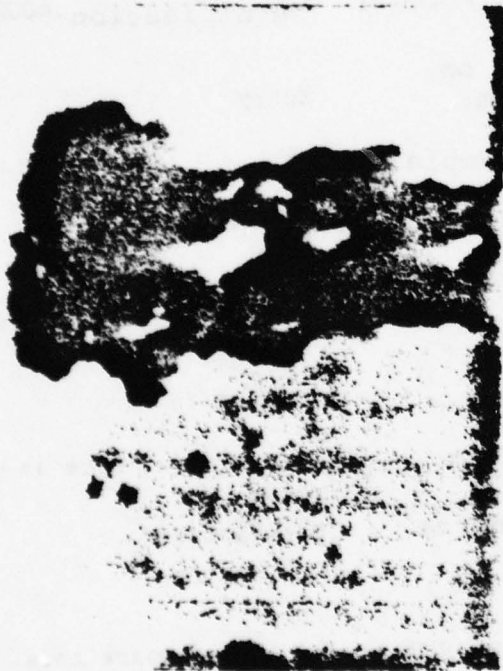
Photo No. F1494-43 Magnification: 400X

View of metallic wear particles
in Bichromatic light.

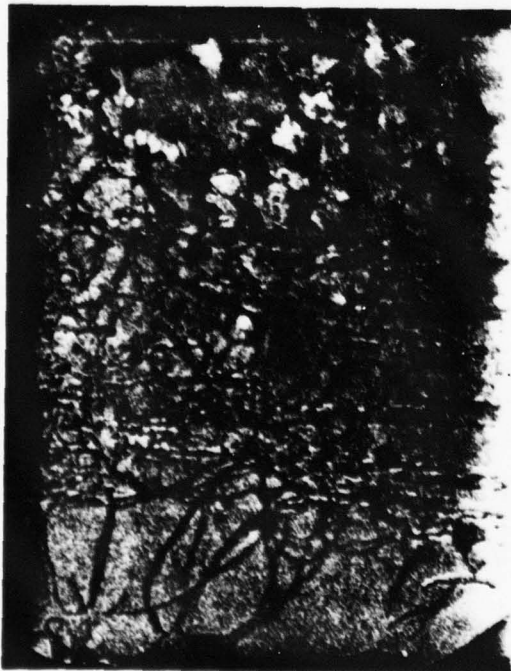
Photo No. F1492-45 Magnification: 400X

Enlarged (400X) Bichromatic light view of metallic wear particles against background of web-like organic material. See also heated Ferrogram (Photo No. F1492-46).

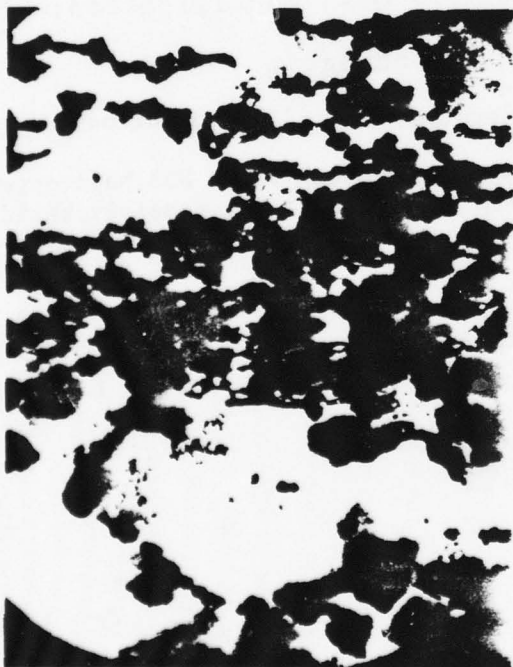
Photo No: F1943-1 Magnification: 400x

Low wear metal concentration. The primary
difference to the above reference sample
is the presence of oxides and compounds
that may be wear associated or contaminants.
Bearing appears normal

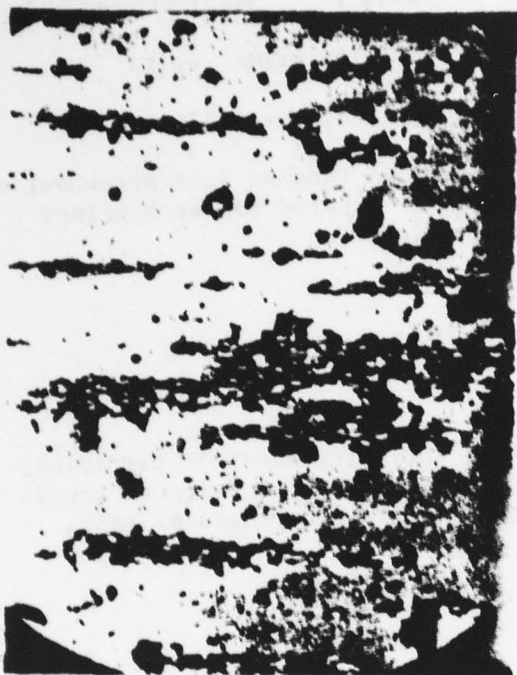
Photo No: F1964-1 Magnification: 400x

Clean Ferrogram in terms of residual grease
and contaminants. Larger free metal particles
($> 10 \mu\text{m}$) give appearance of repeated
passage through rolling contact.

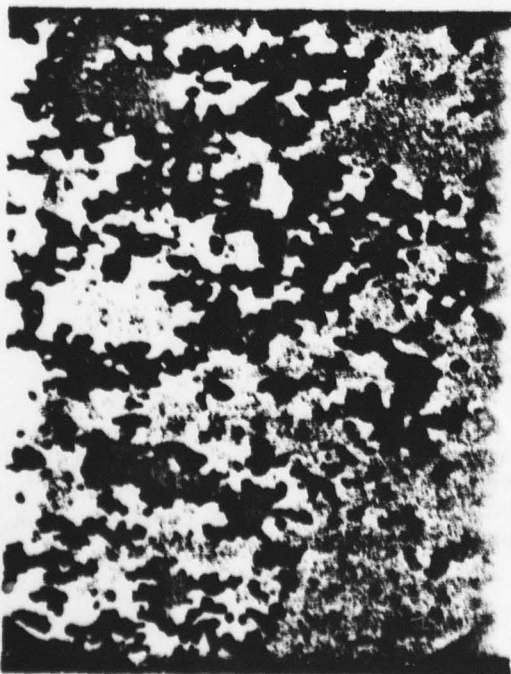
Photo No: F1965-1 Magnification: 400x

Heavily contaminated.

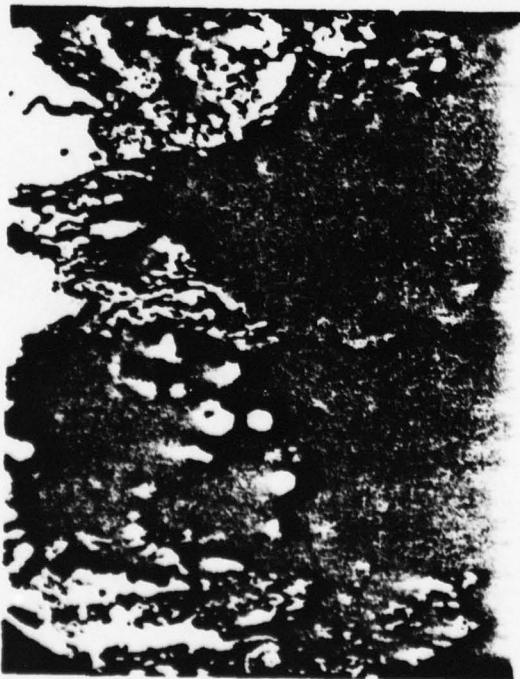
Photo No: F1957-1 Magnification: 400x

Heavy free metal deposits.
